GT2002-XX

Characterization of Ceramic Matrix Composite Fasteners Exposed in a Combustor Liner Rig Test

Michael Verrilli and David Brewer

NASA Glenn Research Center
Cleveland, OH

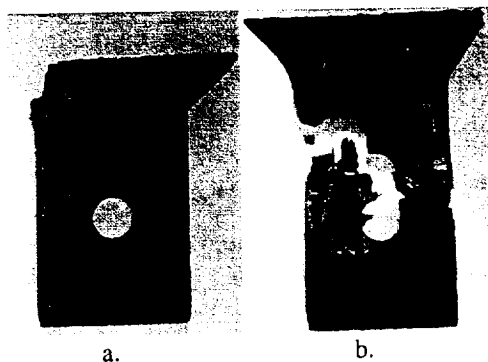
fastener was observed for about 60% of the fasteners removed intact. An extreme example of the observed damage mode is shown in Fig. 4a. This particular fastener could not be subjected to post-exposure destructive testing, but the majority of fasteners with cracks and chipping in the "ears" such as this had less severe damage and thus could be tested. Other fasteners failed in the shank region (Fig. 4b). Damage in the shank was most often observed when difficulties were encountered while removing the metallic nut from the threaded clevis (Fig. 2). About 25 % of the total fastener set was not suitable for destructive testing because of either severe "ear" damage such as in Fig. 4a or failure while attempting to remove them from the rig.

Figure 4 – Damage of fasteners after removal from the sector rig.

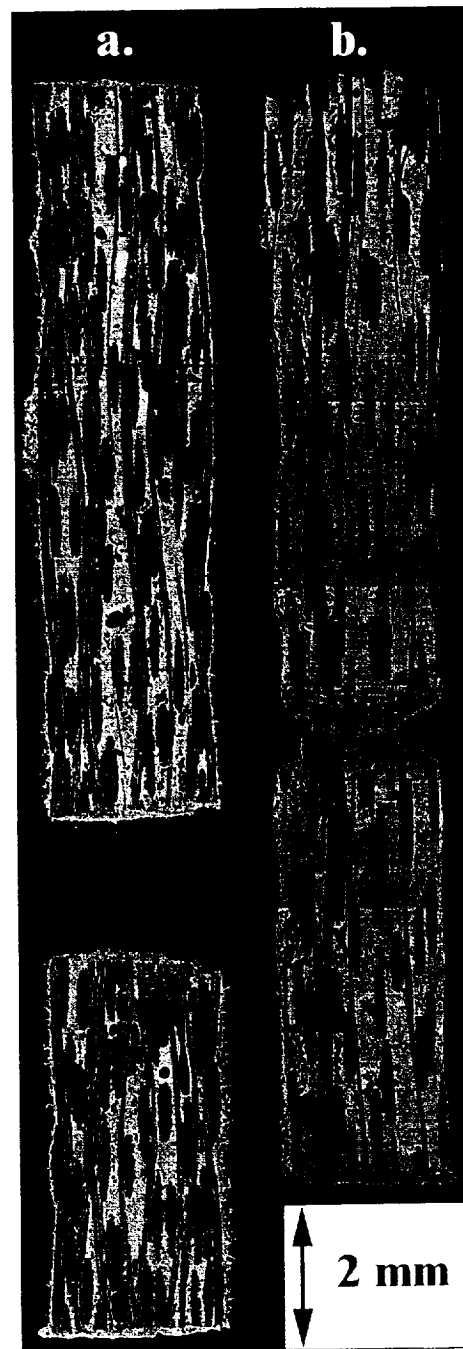
A comparison of the microstructures of an as-manufactured fastener and one that was exposed in the combustion environment for 145 hours is shown in Fig. 5. The longitudinal, through-thickness cross sections reveal porosity in both fasteners. The large pore, in the as-manufactured fastener, exists in the head region. The most notable feature can be seen in the head of the exposed fastener in the form of fiber and composite damage. The dark regions indicate locations where fibers tows are missing due to preferential attack of the Sylramic fibers. This attack is due to the reaction of the boron nitride fiber interface with water vapor, present in the combustion gases [6]. Recession of SiC in a combustion environment can also occur due to SiO_2 scale volatility [7].

Figure 5 – Cross-sections of SiC/SiC fasteners, a) as-manufactured, b) exposed for 145 hours.

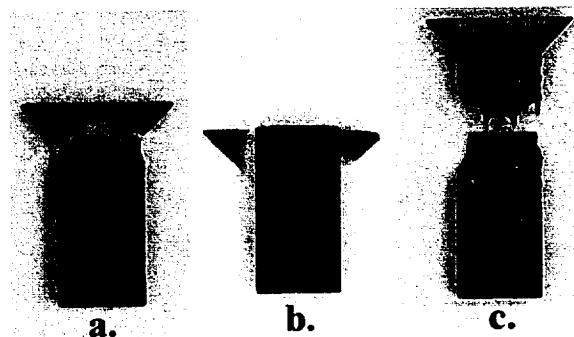
The tensile failure mode observed for all the as-manufactured Miller fasteners is shown in Fig 7a. Approximately 17% of the combustion-exposed fasteners failed in the same manner, which is the desired failure mode [4]. Failure of the fastener through shear failure of the “ears” of the head occurred in 70% of the exposed fasteners (Fig. 7b) and was associated with observed “ear” damage documented prior to destructive testing. The failure mode of the rest of the exposed fasteners was associated with pre-existing cracks, such as seen in Fig. 7c.

Figure 7 – Failure modes of tensile-tested SiC/SiC fasteners, a) as-manufactured material, b) “ear shear failure of exposed material, c) failure associated with pre-existing cracks.

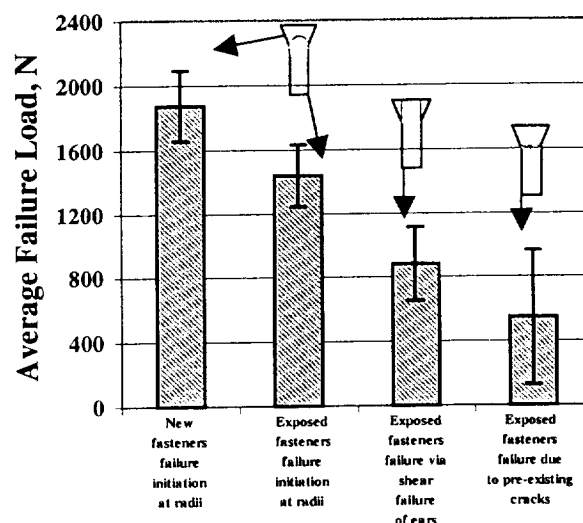
The average failure load for the Miller fasteners as a function of failure mode is shown in Fig. 8. The as-manufactured fasteners failed at an average load of about 1900 N, while combustor-exposed fasteners that failed in the same mode had a 25% lower failure load. Failure of the fastener through “ear” shear failure yielded a failure load of 900 N. Those fasteners that failed due to pre-existing cracks had the lowest average failure load, 550 N.

Figure 8 – Failure mode versus failure load for SiC/SiC fasteners tensile tested at 25 °C.

Comparing data for as-manufactured and for exposed fasteners that failed in the same manner as unexposed ones, an assessment of the material degradation due to combustion exposure can be made. A 25% reduction in failure load was measured for fasteners after 50 hours of exposure (Fig. 8). Additional damage as described above was likely responsible for the switch

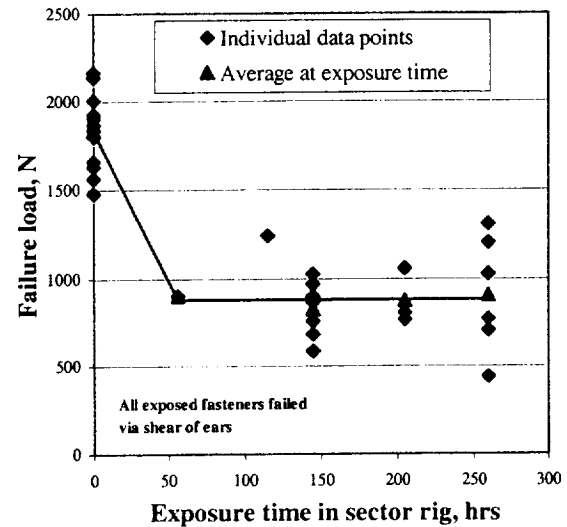
The effect of exposure time can be seen by examining data for fasteners that attached one combustor liner part, the lean transition liner (LTL). The RQL sector rig liner set consisted of twelve LTL's, each held in place with two Miller fasteners, Fig. 9. The exposure temperatures of the different liner parts in the sector rig varied. In addition, combustion gas chemistry and flow rate varied in different regions of the rig. Examination of fastener data for only one part can eliminate potential failure load differences due to varying exposure conditions. During the course of the 260 hours of rig operation, several of the LTL's and their fasteners were removed for reasons described earlier, resulting in the largest number of fasteners exposed for different times from a single part type. To eliminate the effect of failure mode on failure load, only data for LTL fasteners that failed via shear of the “ears” is shown as a function of exposure time in Fig. 10. Data for the as-manufactured fasteners is shown as well. Exposure of 50 hours reduced failure loads by

50% relative to the as-manufactured fasteners. The average fastener failure load of about 900 N was the same for all exposure times, up to the maximum of 260 hours. Note that during sector testing, LTL fasteners reached a maximum temperature of about 1200 °C at the head surface subjected to combustion flow.

Figure 10 – Lean Transition Liner fastener failure loads after exposure in the sector rig.
